OmegaWrap® EG Composite System Utilized in Joint Repair to Reinforce Leaking Defect

By Allan Edwards

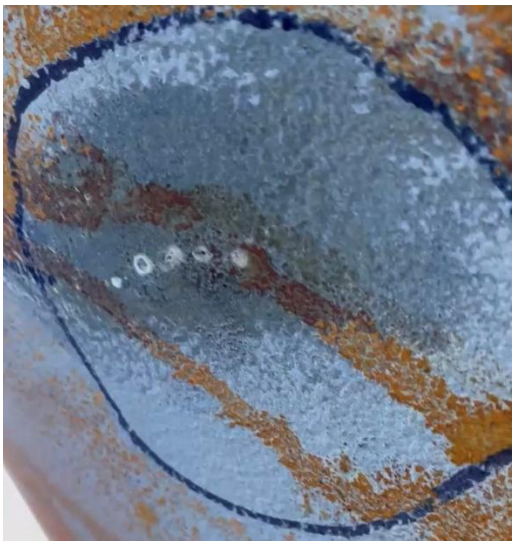
A 30-inch transmission pipeline in West Virginia needed an expedited repair when a 1 3/8-inch-long leaking defect with a 42% Lower Explosive Limit (LEL) that had developed at the site of a previous composite repair installation. The previous composite installation had been performed to repair the existing leak, but hydrocarbons present at the leak site compromised the performance of the original composite wrap. While composite systems have been extensively validated as an effective method of pipeline repair, they are not "pressure-containing" systems and as such are not equipped to handle leaking defects without additional reinforcement.

Due to the tenuous nature of the leak site, the operator did not wish to fully remove the previous composite installation. Instead, the repair site was ground down until fully exposed and then treated with the Resimac metal repair compound and reinforcing fabric to seal the leak defect. Once the Resimac was fully cured, OmegaWrap® load transfer putty material

was applied around the perimeter of the metal repair compound to fill any surrounding anomalies. The OmegaWrap® EG composite system was then installed over the repaired base metal with considerable margin on either side of the defect. The final e-glass repair was five feet in length, and the entire process—including installer training, initial grinding, surface preparation, and installation of both the Resimac repair and the e-glass system—was completed within a twelve-hour time frame. The operator then elected to monitor the repair site for seven days prior to backfilling to verify that the LEL levels remained within the 10% target range. The final LEL reading was 0% at the time of backfill, indicating a complete leak seal.
