Results of the Long-Term Subsea 10,000hr Testing

Final Report

Bureau of Safety and Environmental Enforcement / Pipeline and Hazardous Materials Safety Administration

SES Document No.: 1461191-PL-RP-04 (Rev 0)

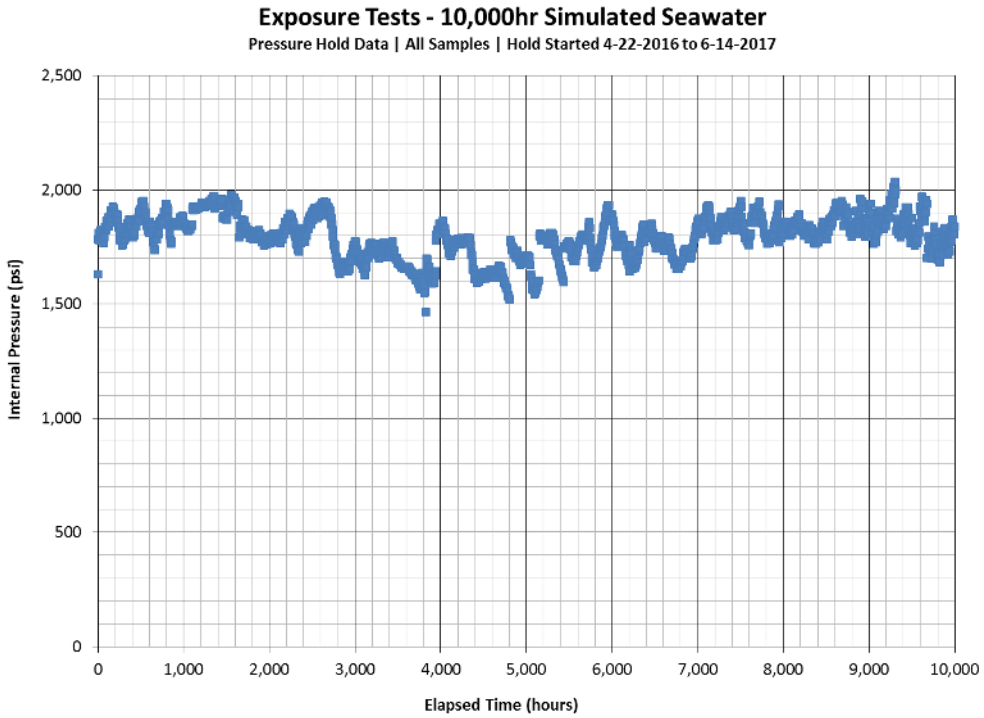
Figure 4-3: Pressure vs. time plot for all samples during 10,000hr pressure hold

All 15 samples survived the 10,000hr salt water exposure tests without leaking. As shown in Figure 4-3, the internal pressure was maintained between 1,500 psi and 2,000 psi during the 10,000 hours. All samples were connected to a common pressure line and pressure transducer. The weldable strain gages installed under the composite repairs were not monitored during the pressure hold. Figure 4-4 is a photograph of the 15 samples following the pressure hold and draining of the saltwater bath.

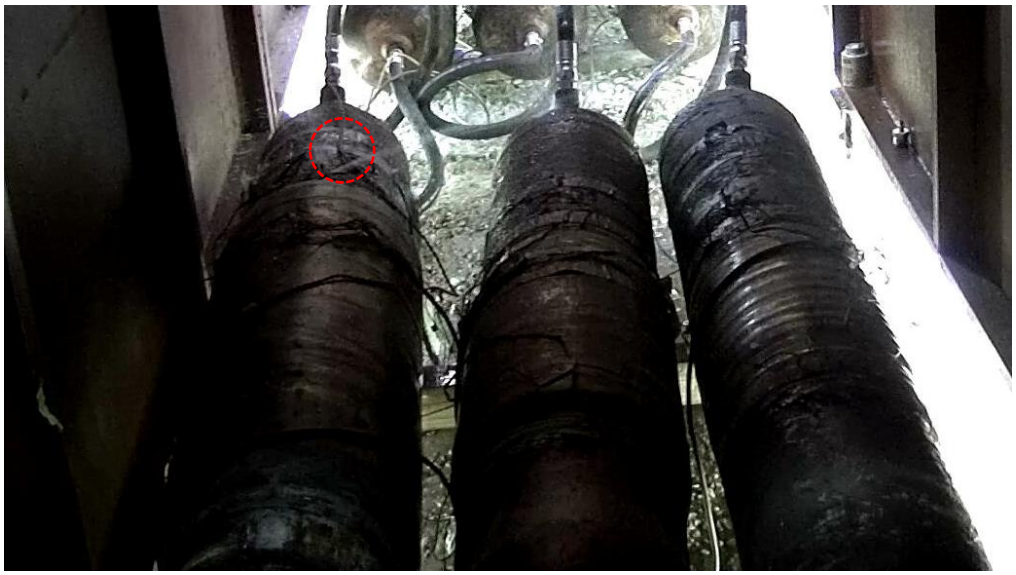
Figure 4-10: Photograph of failure (circled) during cycling of Manufacturer A's Tension sample.

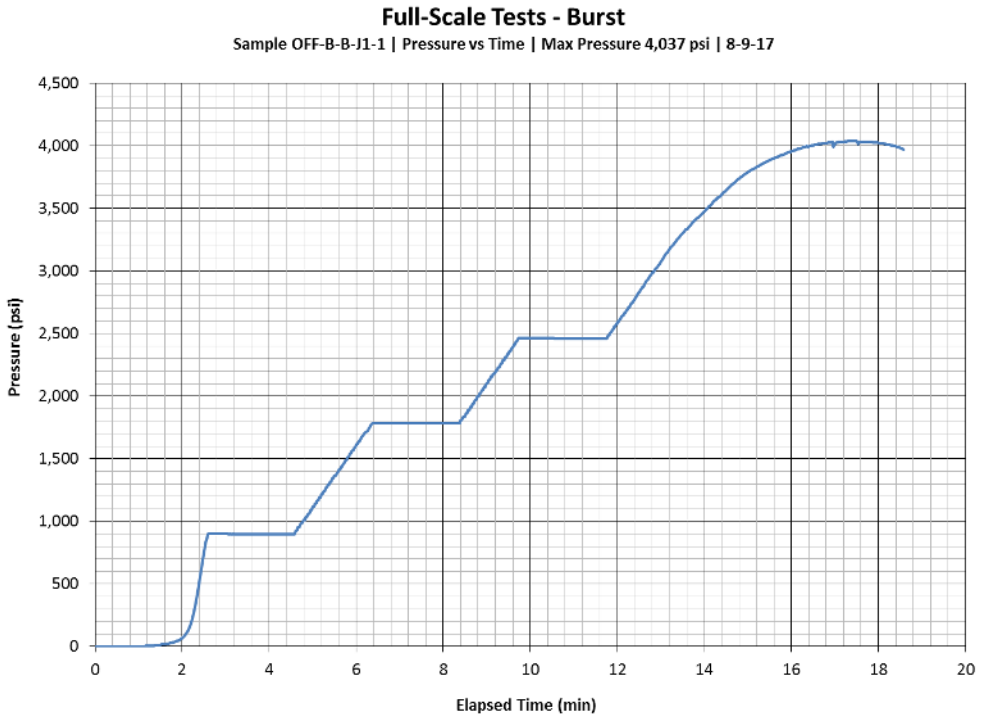
Figure 5-3: Internal pressure vs. elapsed time for Manufacturer B's burst sample (OFF-B-B-J1-1)

Manufacturer B's burst sample (OFF-B-B-J1-1) reached a maximum pressure of 4,037 psi (163% SMYS) before failure occurred outside of the repair in the base pipe (Figure 5-2). There was no visible damage to the outer surface of Manufacturer B's repair following the test. Figure 5-3 displays the internal pressure vs. elapsed time for the burst test. The three (3) hold points at 36%, 72%, and 100% SMYS are visible in the plot. The hoop strain measurements in Figure 5-4 indicate significant deformation in the base pipe and corrosion region during the test (corrosion region gage 2H was the only operable gage during the burst of this sample). The gages on the outside of the composite repair measured little in the way of hoop strain during the test.

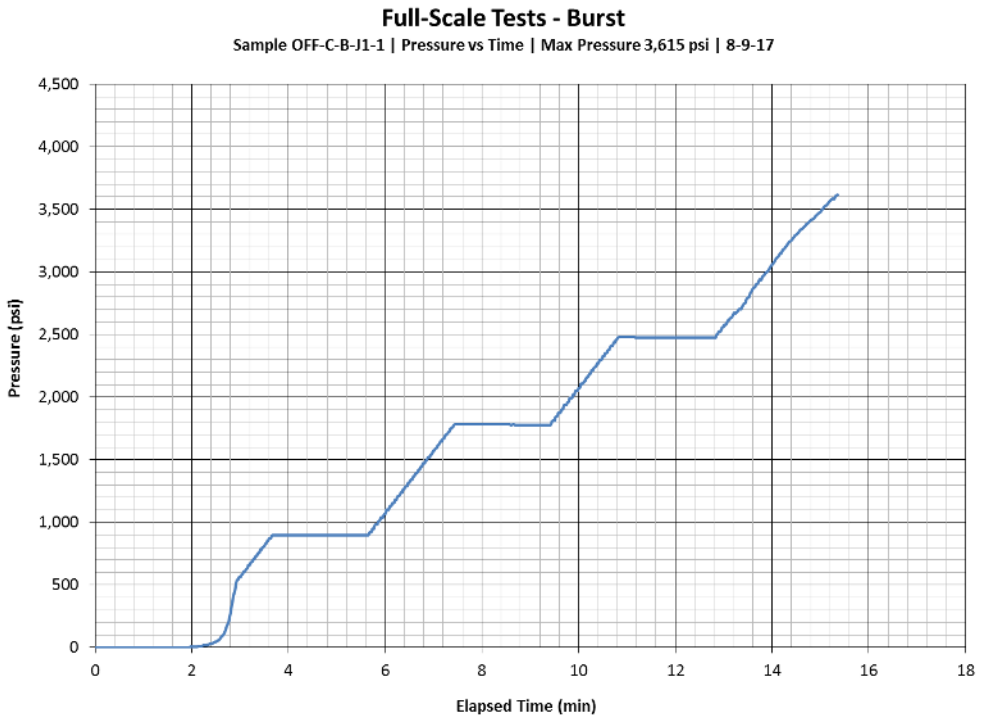
Figure 5-6: Internal pressure vs. elapsed time for Manufacturer C's burst sample (OFF-C-B-J1-1)

The Manufacturer C's burst sample (OFF-C-B-J1-1) reached a maximum pressure of 3,615 psi (146% SMYS) before failure occur in the simulated corrosion defect as shown in Figure 5-5. Figure 5-6 displays a plot for the internal pressure vs. elapsed time during the burst. Similar to Manufacturer B's sample, the hoop strain measurements in Figure 5-7 also indicated deformation in the base pipe with little change on the surface of the composite repair. No gages in the simulated defect were operable during the burst.

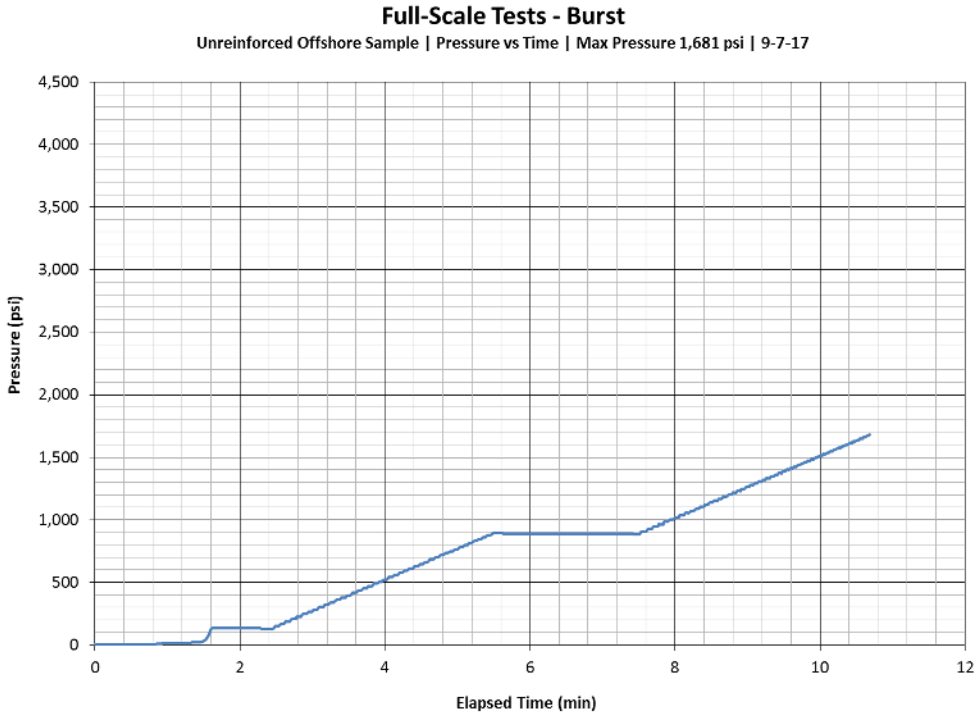
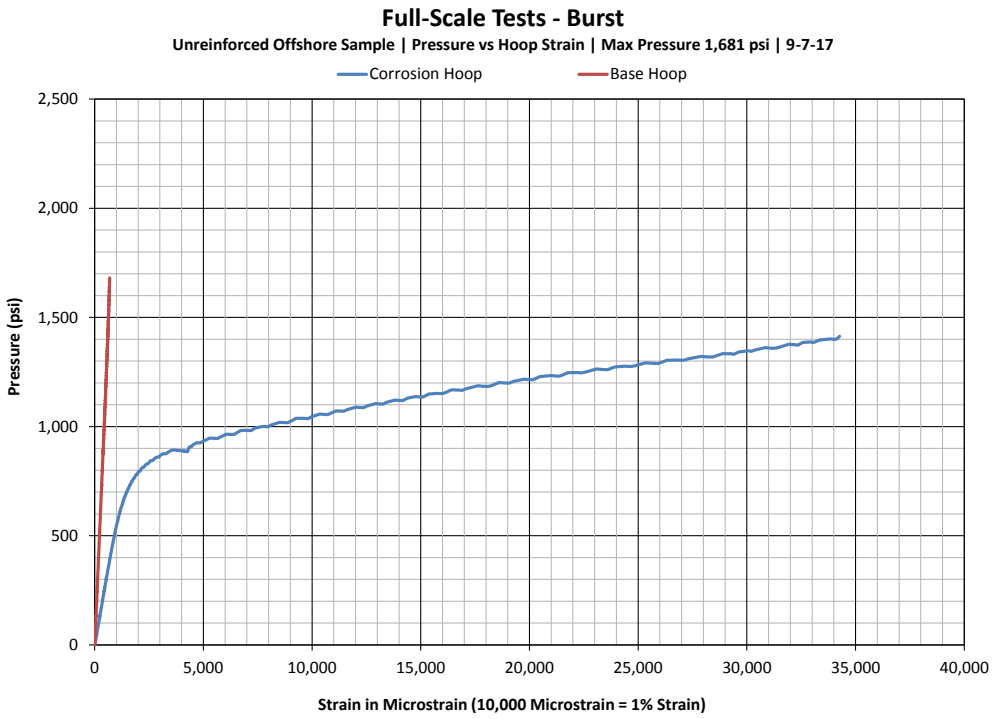
The 75% corrosion unreinforced sample burst at a pressure of 1,681 psi (68% SMYS) in the corrosion region. This sample did not reach the second hold point of 72% SMYS. A strain gage installed in the corrosion region indicated yielding occurred at just over 600 psi.

Figure 5-8: Internal pressure vs. elapsed time for unreinforced sample with 75% corrosion defect

Figure 5-9: Internal pressure vs. hoop strain for unreinforced sample with 75% corrosion defect

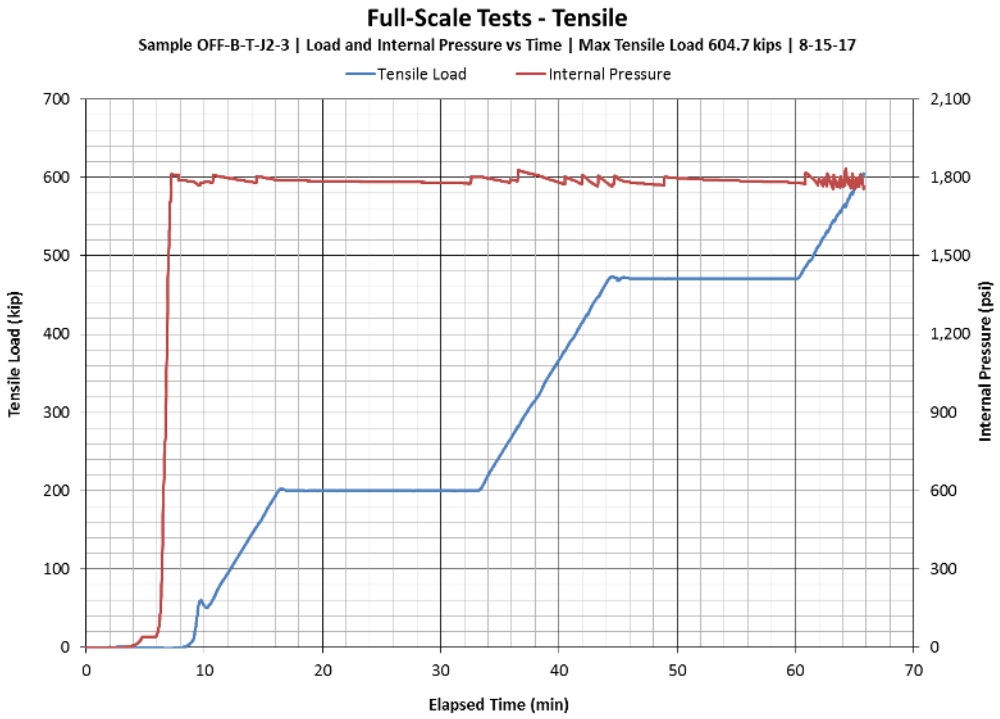
Figure 5-13: Load and internal pressure vs. elapsed time for Manufacturer B's tensile sample (OFF-B-T-J2-3)

Manufacturer B's sample reached a maximum applied tensile load of 604.7 kips as shown in Figure 5-13 before failure. Failure occurred when the sample was no longer able to maintain the internal pressure, and a leak path developed from the corrosion defect to the edge of the repair. SES inspected the repair following the failure, but there was no other visible damage.

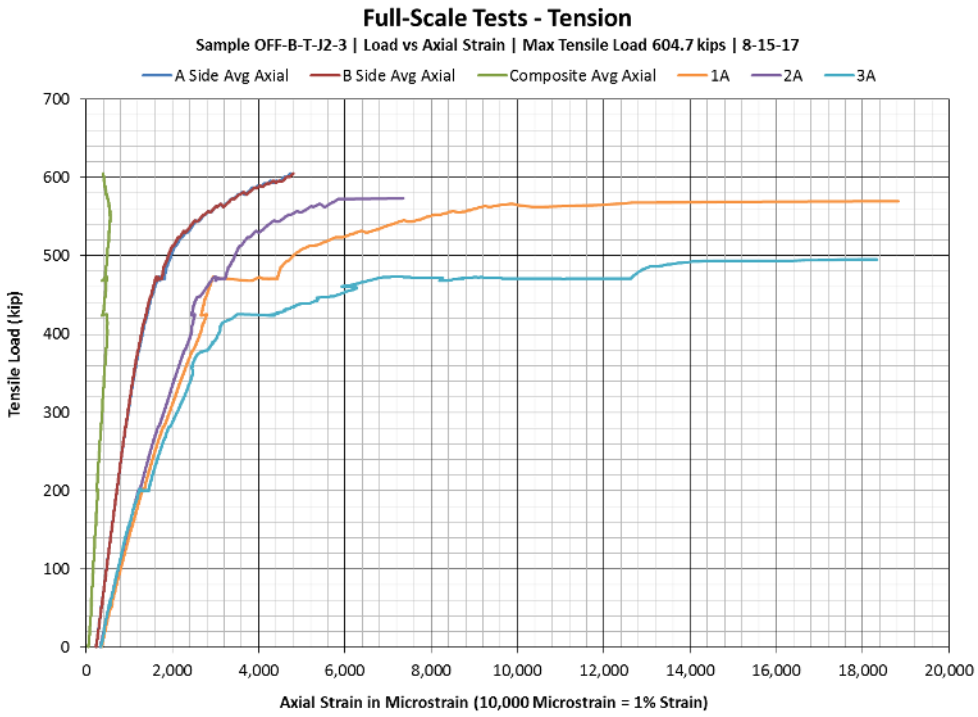
Figure 5-14: Tensile load vs axial strain for Manufacturer B's tensile sample (OFF-B-T-J2-3)

Strain measurements in Figure 5-14 indicate that the base pipe to either side of the repair had begun to plastically deform and reached a maximum axial strain of 4,700 to 4,800 microstrain before failure in the corrosion defect. It should be noted that the base pipe axial strains in Figure 5-14 are the average of the four strain gages installed per side. Manufacturer B's sample had three operable axial gages in the corrosion defect that indicated a significant increase in strain after an applied load of 350 kips. A maximum axial strain of 559 microstrain was measured on the outer layer of the composite. This is not insubstantial for Manufacturer B's carbon fiber repair and indicates that load was being transferred throughout the composite.

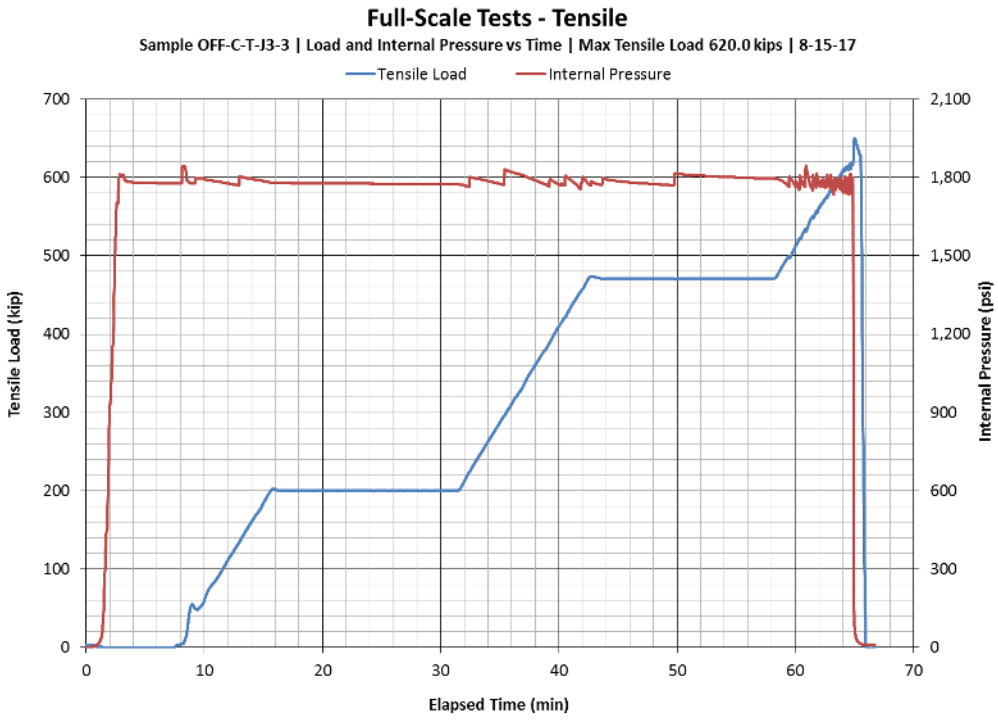
Figure 5-15: Load and internal pressure vs. elapsed time for Manufacturer C's tensile sample (OFF-C-T-J3-3)

Manufacturer C's sample reached a maximum applied tensile load of 620.0 kips as shown in Figure 5-15 before failure. The failure occurred before the five minute hold at 620 kips began. The sample was no longer able to maintain pressure at this load and a leak path developed from the corrosion defect to the edge of the repair. Post-test examination of the repair revealed cracks near the edge of the repair as shown in Figure 5-17.

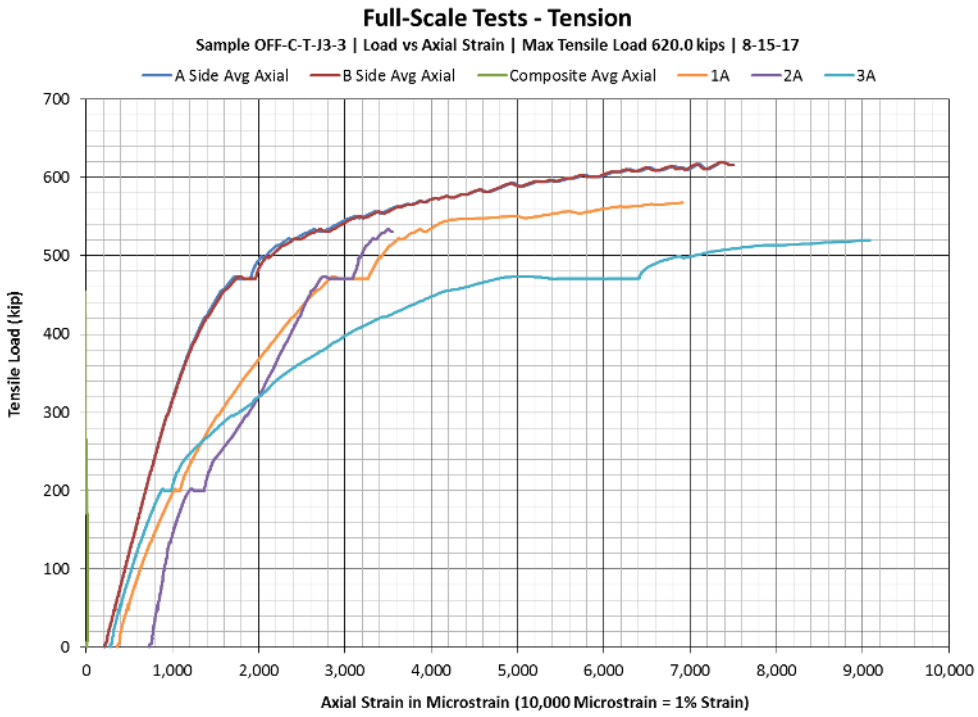
Figure 5-16: Tensile load vs axial strain for Manufacturer C's tensile sample (OFF-C-T-J3-3)

The strain measurements in Figure 5-16 indicate plastic deformation in the base pipe on both sides of the repair which reached nearly 8,000 microstrain in the axial orientation before the failure. Manufacturer C's sample also had three operable axial strain gages in the corrosion defect at the start of the test. Gage 3A reached a maximum axial strain of 9,000 microstrain at an applied load of just over 510 kip before the gage failed. The axial strain on the surface of the composite remained near zero during the test.

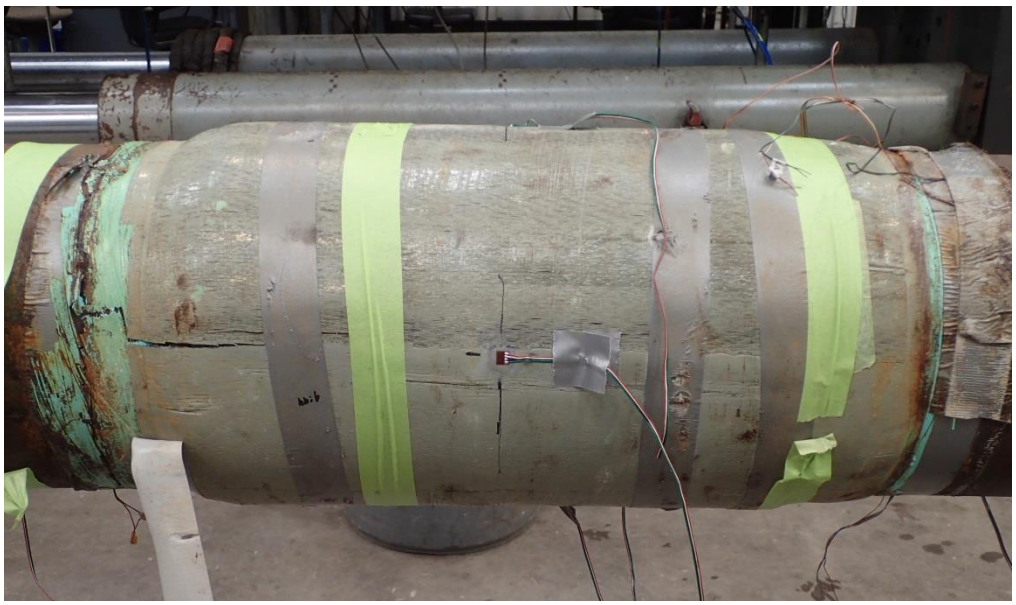
Figure 5-17: Manufacturer C's tensile sample (OFF-C-T-J3-3) post test with cracks near edges

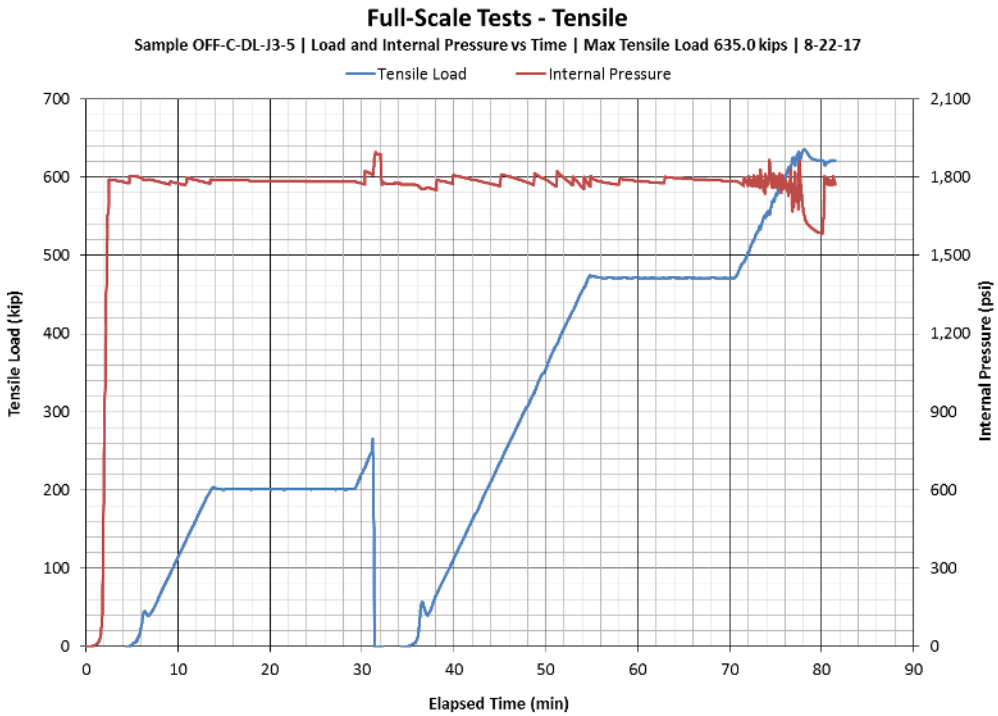
Figure 5-18: Load and internal pressure vs. elapsed time for Manufacturer C's delamination sample (OFF-C-DL-J3-5)

The test results in Figure 5-18 indicate that the delaminations had little effect on the repair's tensile test performance. Manufacturer C's delamination sample reached a maximum applied tensile load of 635.0 kips, which was slightly higher than the previous Manufacturer C tensile sample with no delaminations. The drop in load in Figure 5-18 was to repair a leak in a pressure line and does not represent a failure of the sample. Similar to the previous tests, failure occurred when a leak path developed in the simulated corrosion region under the composite repair.

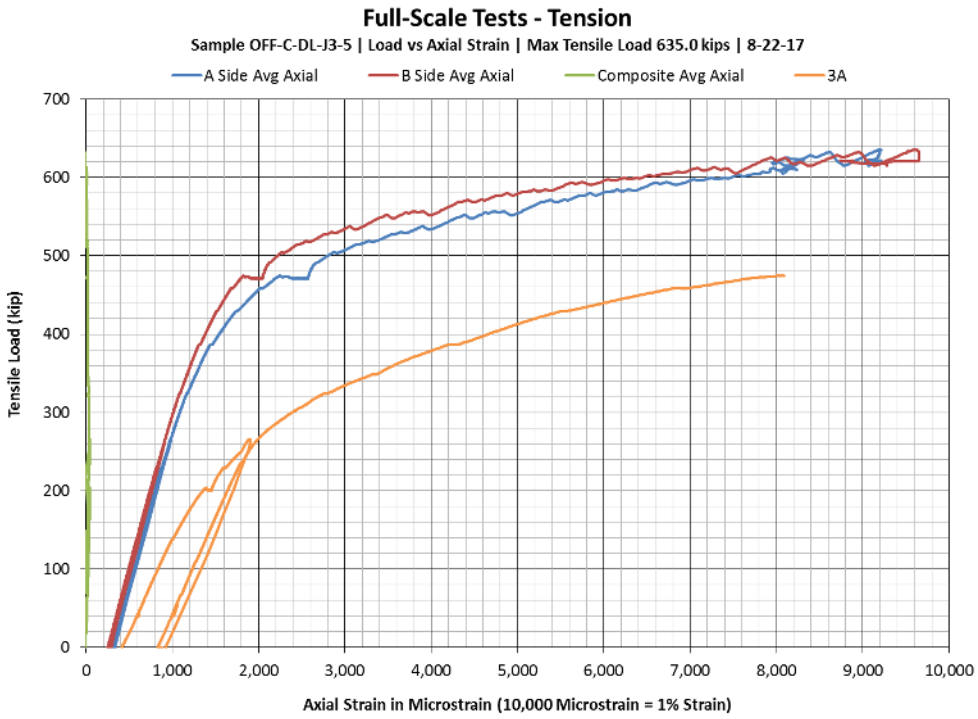
Figure 5-19: Tensile load vs axial strain for Manufacturer C's delamination sample (OFF-C-DL-J3-3)

Axial strain measurements in Figure 5-19 indicate the base pipe in this sample reached nearly 10,000 microstrain before failure. The one operable axial strain gage in the corrosion defect reached over 8,000 microstrain before it became inoperable at an applied load of 490 kips. Similar to the previous Manufacturer C tension sample, there was little to no increase in axial strain on the outer surface of the repair. This Manufacturer C repair also exhibited cracks in the repair post-test as shown in Figure 5-20.

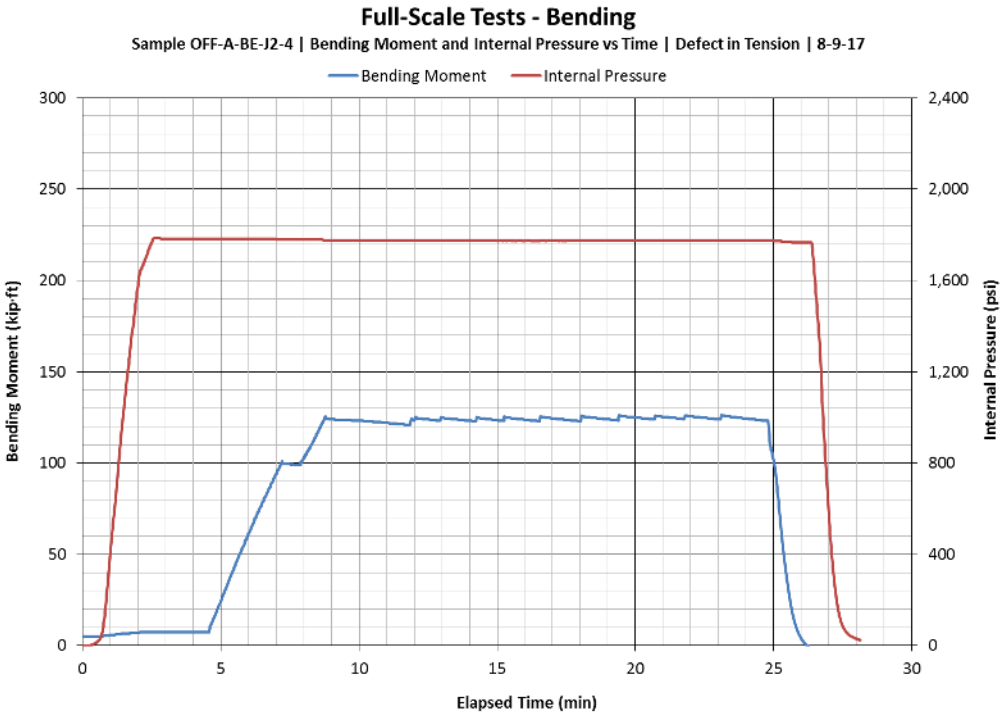
Figure 5-23: Manufacturer A's bending sample (OFF-A-BE-J2-4) moment and internal pressure vs. elapsed time with corrosion defect in tension

Manufacturer A's bending sample survived the first phase of testing to a maximum bending moment of 125 ft·kips with the defect in tension as shown in Figure 5-23. The axial strains in the base pipe and corrosion defect were similar to those observed in Manufacturer B and C's samples (Figure 5-24). After the sample was rotated to place the corrosion defect in compression, the sample failed at a bending moment of 264.6 ft·kips (Figure 5-25). The base pipe axial strains in Figure 5-26 for Manufacturer A's sample were slightly lower than the other bending samples at just over 5,000 microstrain (0.5% strain).

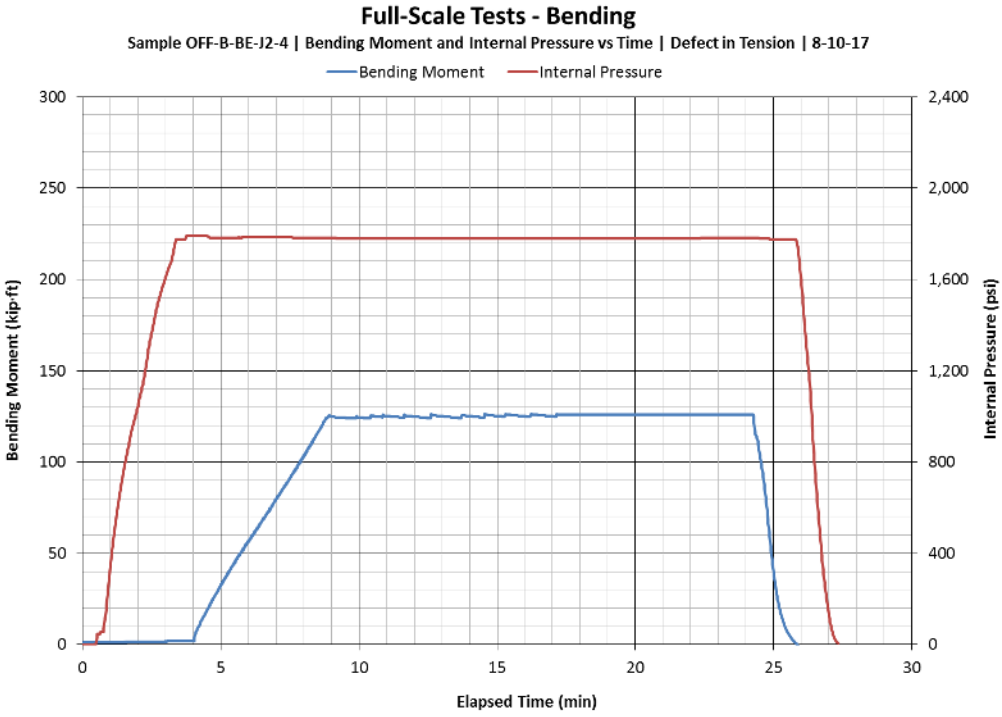
Figure 5-28: Manufacturer B's bending sample (OFF-B-BE-J2-4) moment and internal pressure vs. elapsed time with corrosion defect in tension

Manufacturer B's bending sample completed the first phase the bend test without failure (defect in tension) as shown in Figure 5-28. The bending moment and internal pressure both remained stable during the 15 minute pressure hold. Figure 5-29 indicates the maximum axial strains in the base pipe were under 1,500 microstrain at 125ft·kips. Figure 5-29 does not include any of the weldable strain gages installed under the composite repair as none survived the exposure testing. After the bending moment was removed, Manufacturer B's sample was rotated so the corrosion defect was in compressed.

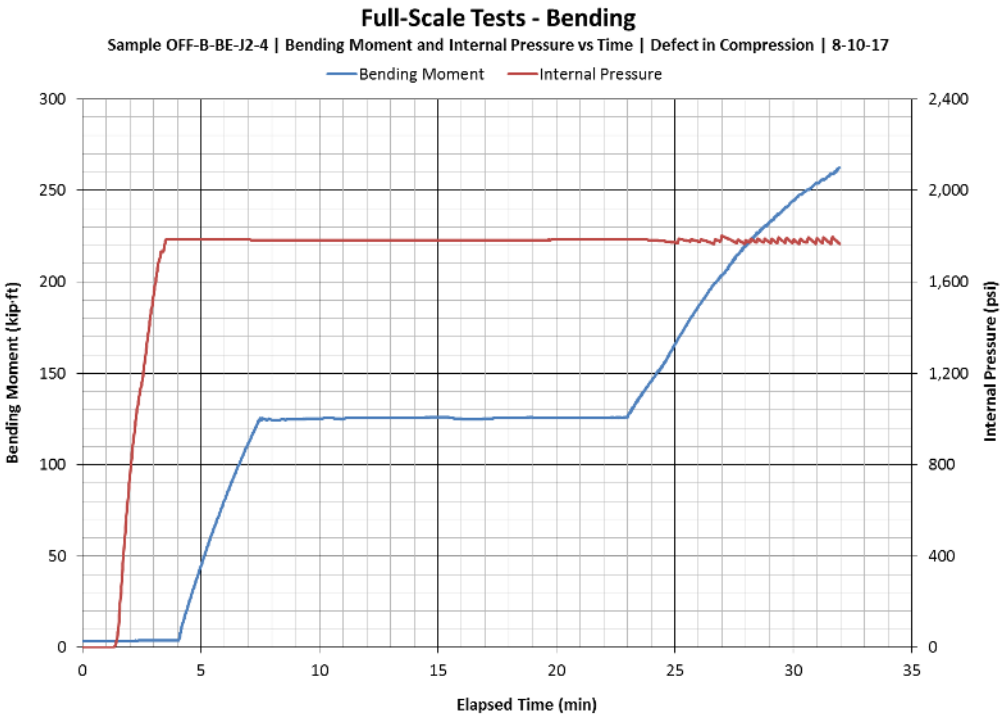
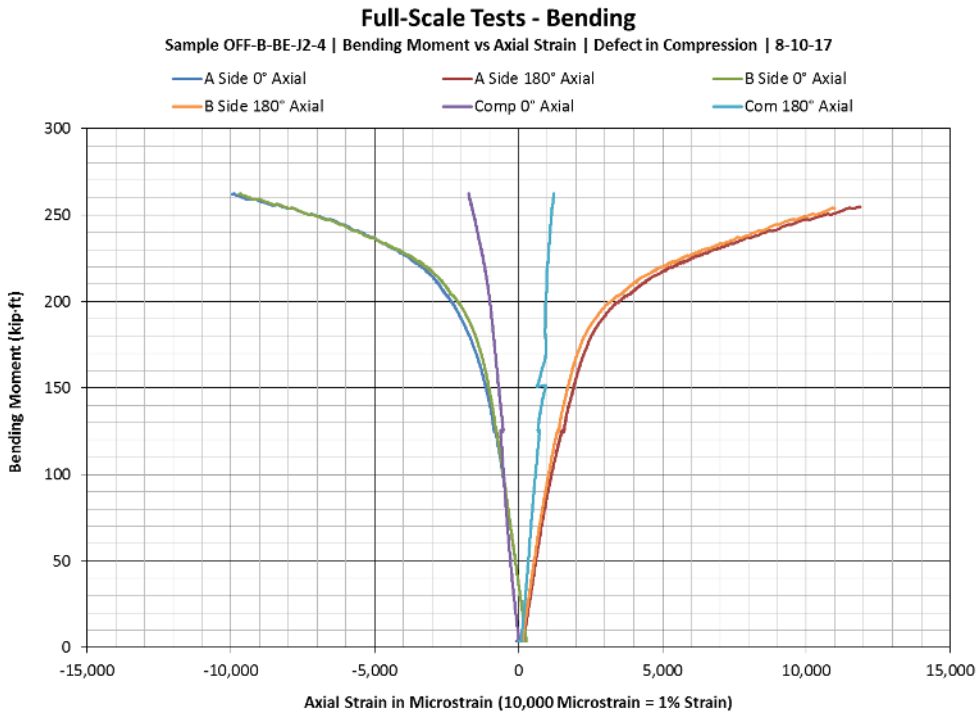
Manufacturer B's sample failed at a bending moment of 262.4 kip·ft with the defect in compression as shown in Figure 5-30. Beyond a load of 175 ft·kips, the internal pressure was difficult to maintain due to deformation in the base pipe. This deformation is confirmed by the base pipe axial strains in Figure 5-31 (note the 0° location is now in compression since the sample was rotated). The maximum axial strain in the composite was 1,230 microstrain (0.12% strain). The maximum axial strain in the base pipe was approximately 11,900 (1.19% strain) at the time of failure. Failure occurred by a loss of internal pressure when a leak path developed from the corrosion defect to the edge of the repair. Figure 5-32 is Manufacturer B's sample post-test after the bending moment was removed. The sample experienced permanent deformation and exhibited a visible curvature following the bend test.

Figure 5-30: Manufacturer B's bending sample (OFF-B-BE-J2-4) moment and internal pressure vs. elapsed time with corrosion defect in compression

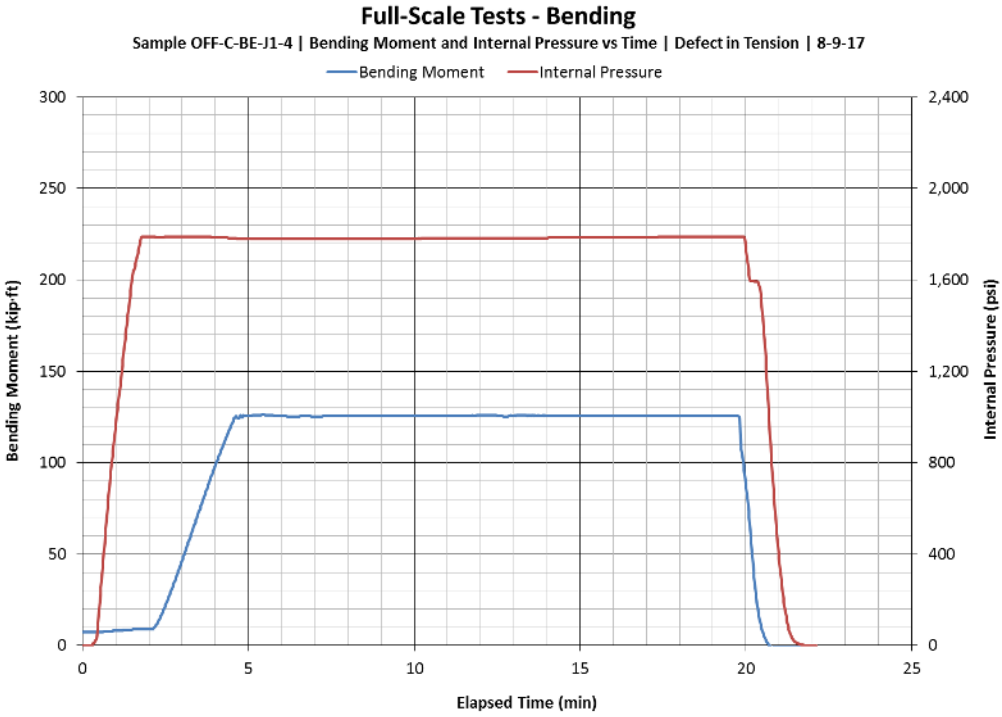
Manufacturer C's sample also successfully completed the first phase of the bend test with the defect in tension. Figure 5-33 displays the bending moment and internal pressure vs. elapsed time for this phase of the test. The base pipe axial strains in Figure 5-34 are similar to those observed in Manufacturer B's sample. Three weldable axial strain gages in the corrosion defect were still functioning after the exposure tests and are included in Figure 5-34. The 3A axial gage in the corrosion defect recorded the highest defect axial strain of 3,100 microstrain during the bend test. After completing the first phase of the bend test with the corrosion defect in tension, the sample was rotated 180° to place the defect in compression for the second phase of the test.

Figure 5-33: Manufacturer C's bending sample (OFF-C-BE-J1-4) moment and internal pressure vs. elapsed time with corrosion defect in tension

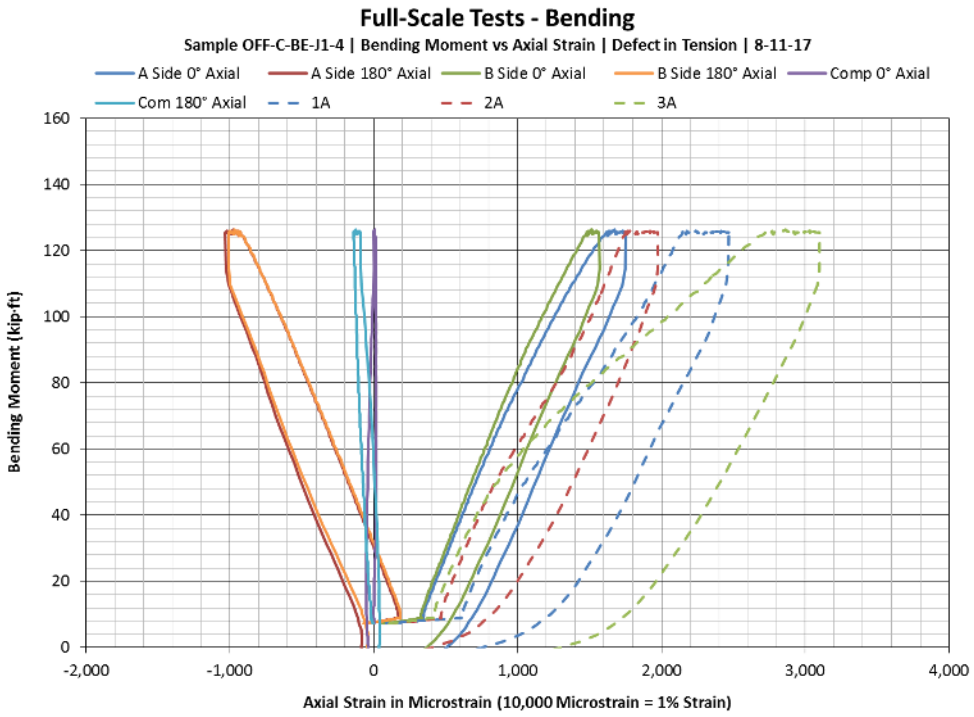
Figure 5-34: Manufacturer C's bending sample (OFF-C-BE-J1-4) moment vs. axial strain with corrosion defect in tension

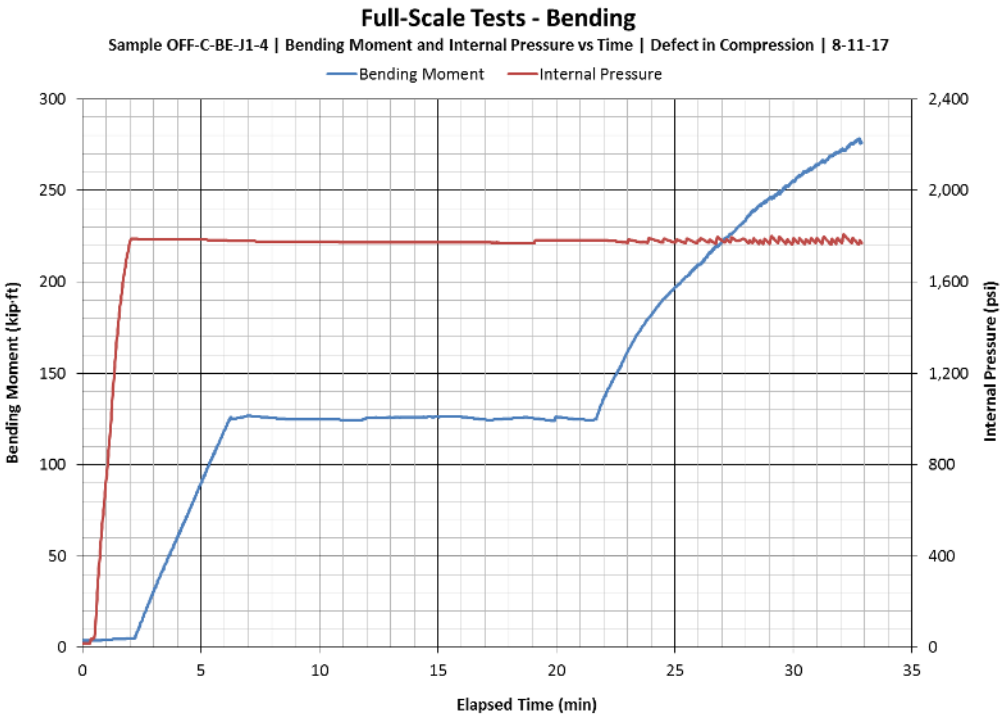
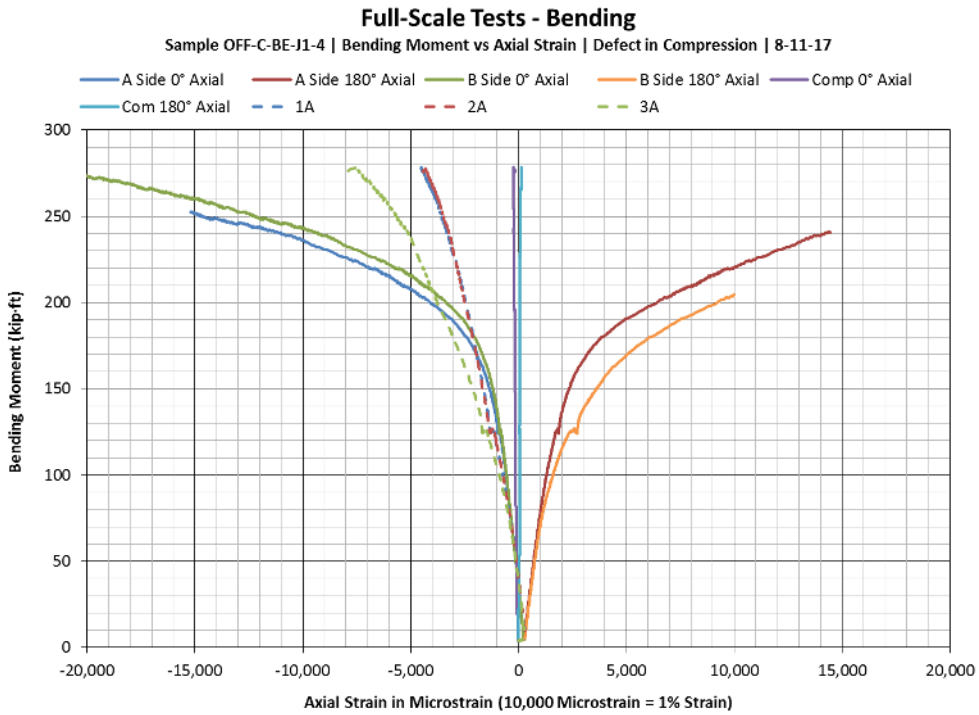
With the corrosion in compression, Manufacturer C's sample reached a bending moment of 278.4 kip·ft as shown in Figure 5-35 before failure occurred at the corrosion defect. Similar to Manufacturer B's sample, the sample began to deform near the end of the test and it became difficult to maintain the internal pressure. Figure 5-36 indicates that the axial strains in the base pipe ranged from 10,000 to 20,000 microstrain (1% to 2% strain) prior to failure. The strains on the outer surface of the composite repair during the test were low (under 300 microstrain) which indicates the majority of the load was carried by the inner layers of the repair. The permanent shape of Manufacturer C's sample after failure and removal the bending moment is shown in Figure 5-37. Unlike Manufacturer B's sample that developed a leak at the edge of the repair at failure, the corrosion defect in Manufacturer C's sample ruptured through the composite as illustrated in Figure 5-38.

Figure 5-35: Manufacturer C's bending sample (OFF-C-BE-J1-4) moment and internal pressure vs. elapsed time with corrosion defect in compression

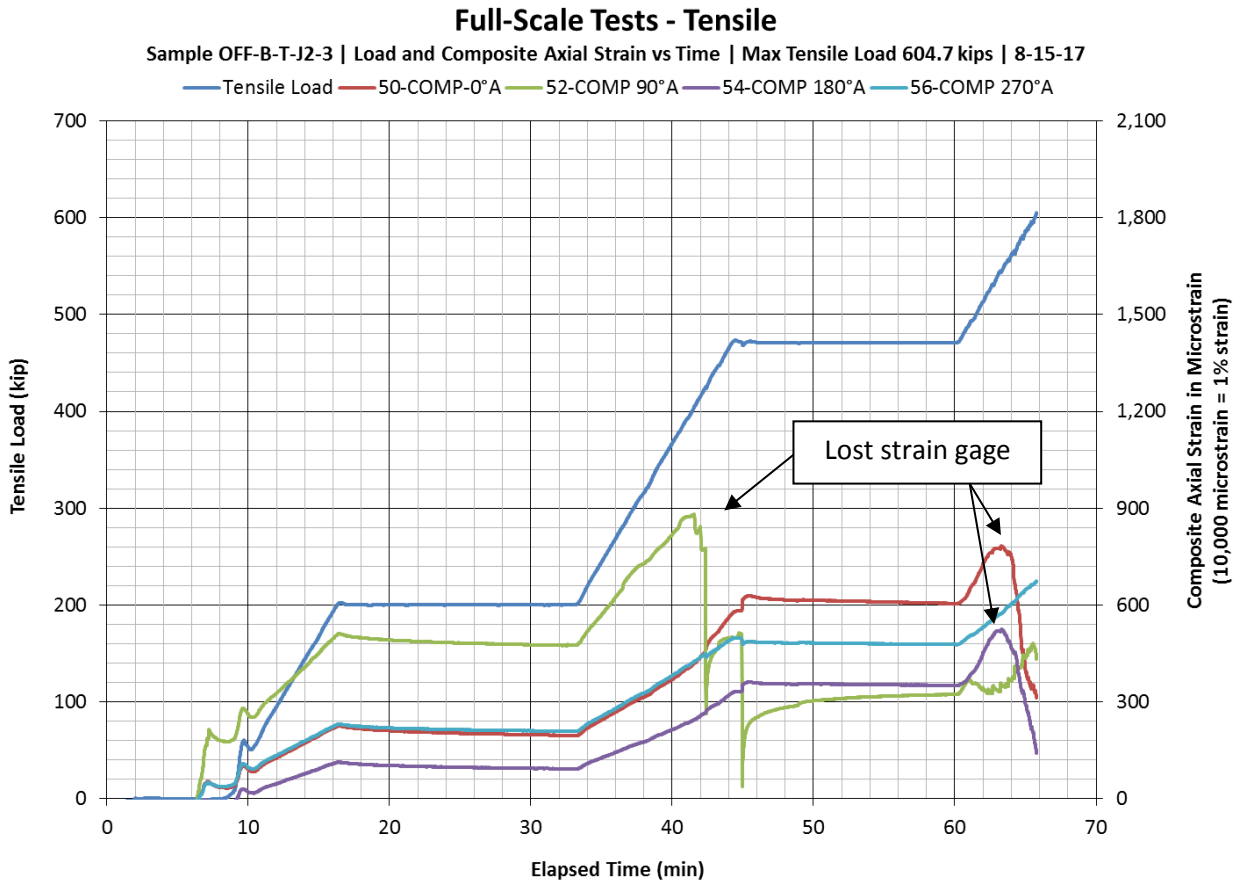
Strain gage results from the tension sample do not point to significant reinforcement being provided by the composite repair. Axial strains in the simulated corrosion region are consistently greater than those recorded in the base pipe outside the repair. This is not necessarily an indication of damage due to exposure testing, but could reflect the design of the composite repair itself. Achieving the test pressure of 72% SMYS shows that adequate reinforcement was provided in the hoop direction, but the tension test requires substantial reinforcement in the axial direction. Although it appears that the composite is not providing a significant amount of reinforcement, it is clear that there is load transfer to the composite due to the correlation between composite axial strain and increasing axial load during testing (Figure 6-2).

Figure 6-1: Plot of axial load and composite axial strain vs elapsed time during tension test

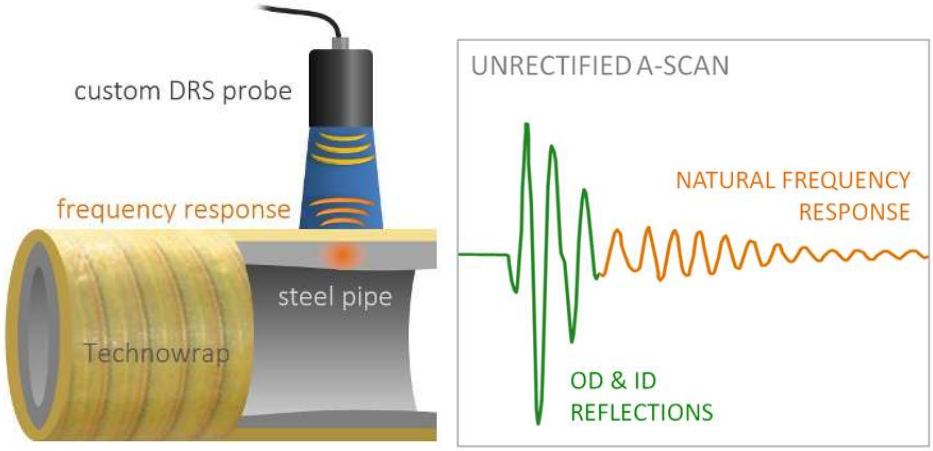
DRS is an innovative ultrasonic inspection technique developed by Sonomatic for corrosion mapping through challenging coatings where the conventional ultrasonic method is ineffective. Low frequency ultrasound (<1 MHz) penetrates the coating and excites the steel, causing it to vibrate at its natural frequencies. Using advanced signal processing algorithms, these frequencies are extracted from the returning signals and used to determine the steel wall thickness (WT) profile (Figure 2).

Figure 2. DRS inspection diagram. The orange part of the signal contains the natural vibration frequencies of the steel, which are used to determine its thickness profile.

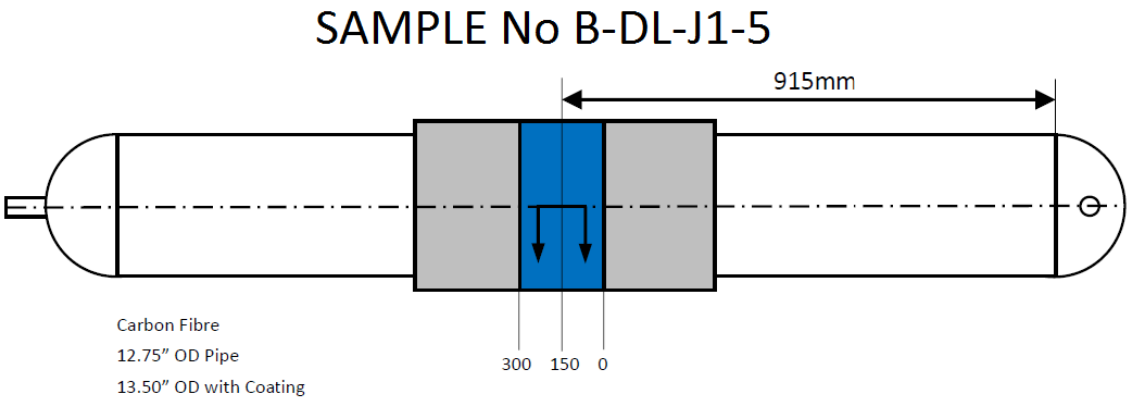
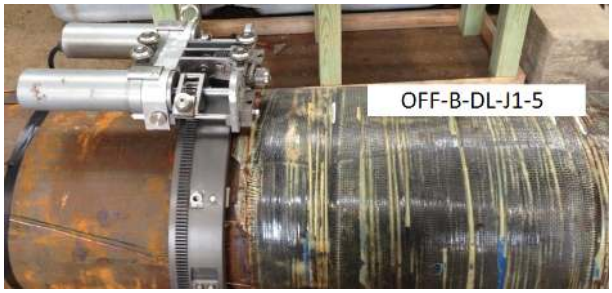
2.3 C-DL-J35

Sample	Repair Type	Repair Thickness inches / mm	DRS Inspection Feasible?	Comment
A-DL-5	Glass Fiber	1.28 / 32.4	N	No signal evident from steel. Attenuation likely due to repair thickness.
A-F-2	Glass Fiber	1.28 / 32.4	N	No signal evident from steel. Attenuation likely due to repair thickness.
C-DL-J35	Glass Fiber	0.24 / 6.1	N	No signal evident from steel. Repair thickness recorded incorrectly? Appears thicker in photos.
B-DL-J1-5	Carbon Fiber	0.38 / 9.5	N	Signal evident from steel in places (see Figure 4). Not consistent enough for DRS to be considered a suitable inspection technique.

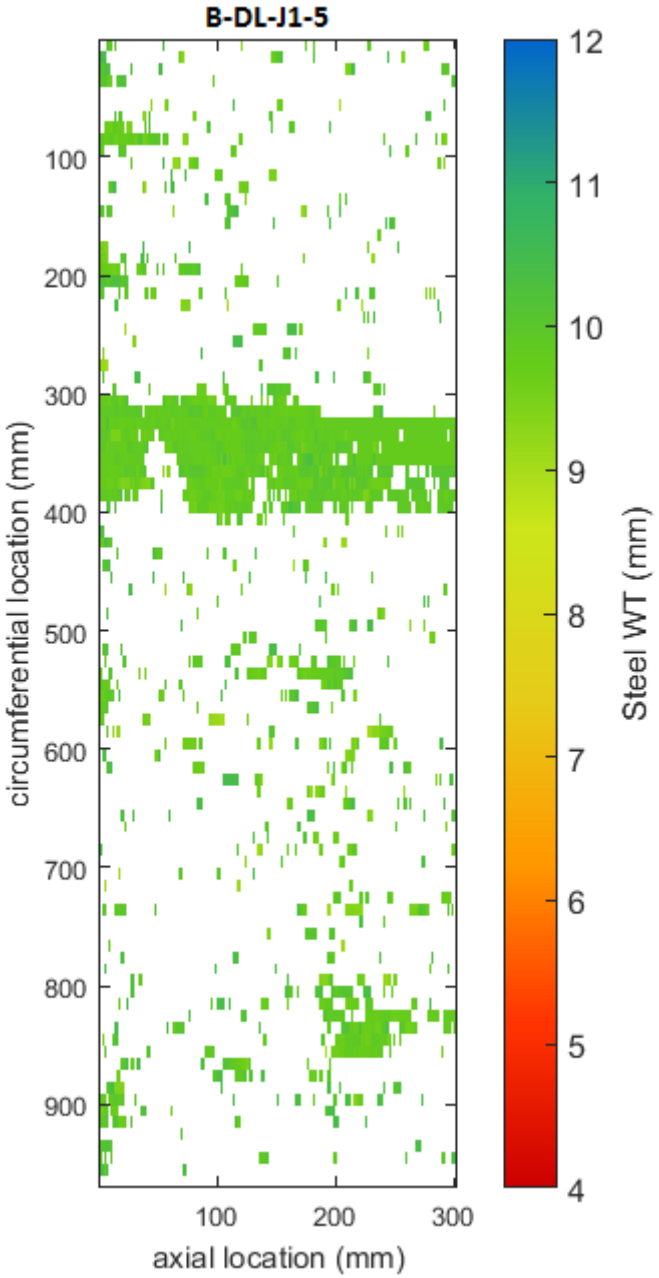
Figure 4. DRS map showing the steel WT where signals penetrated the composite. Although measurements were possible in some locations, the large areas of signal loss demonstrate that DRS is not a suitable inspection technique for this particular design.

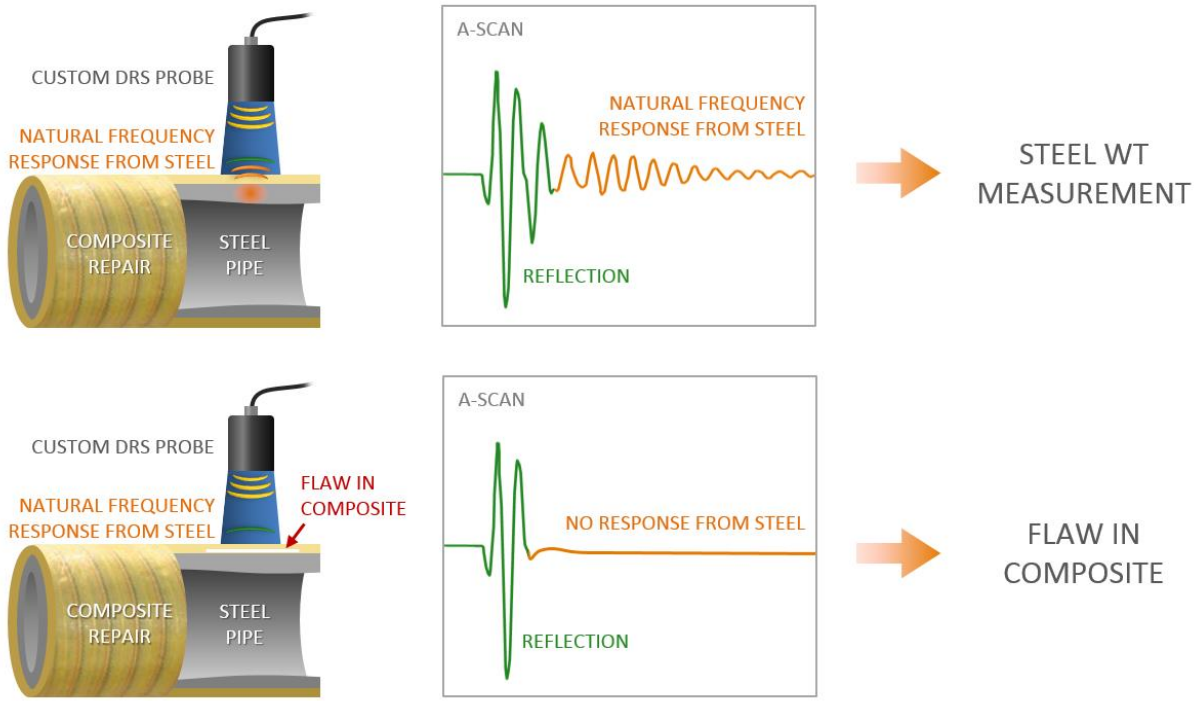
It should be noted that for repairs suitable for DRS inspection, a loss of signal from the steel indicates a flaw in the composite (such as a delamination), as shown in Figure 5 and Figure 6. However, for repairs such as those evaluated in this study, it is not possible to identify delaminations as they are indistinguishable from the loss of signal due to attenuation in the thick composite.

Figure 5. Diagram illustrating the effect of a flaw in the composite on the DRS signals.
