Results of the Long-Term Subsea 10,000hr Testing

Final Report

Bureau of Safety and Environmental Enforcement / Pipeline and Hazardous Materials Safety Administration

SES Document No.: 1461191-PL-RP-04 (Rev 0)

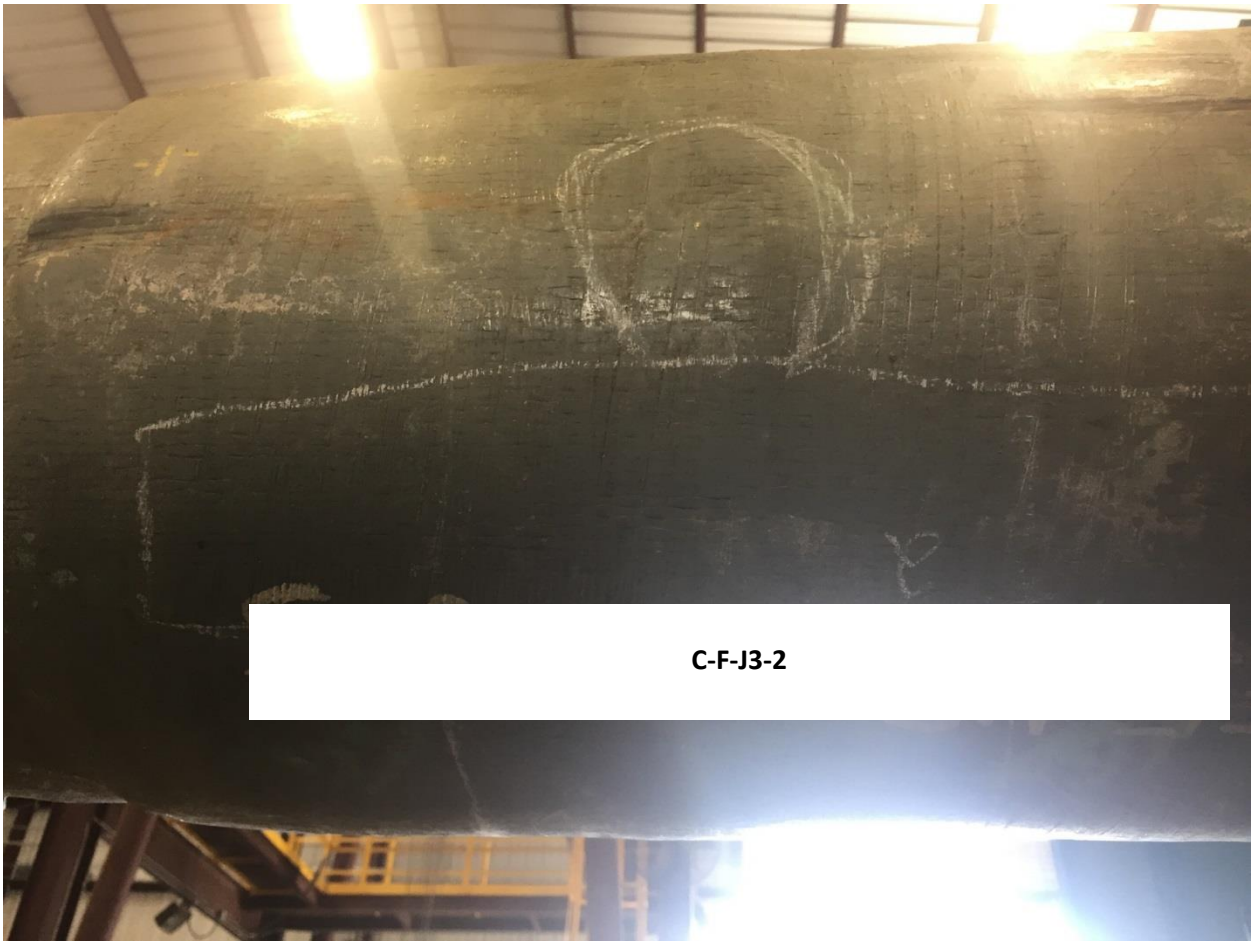
Subsea Composite Test Sample # C-F-J3-2

Indication # 2 (All around the circumference of the wrap. From Nozzle end – Starting 2” to 3” from edge of wrap; 6” wide (radius)).

- Note these could be non–relevant indications based on the inconsistency of the readings and lower amplitude of the signals.

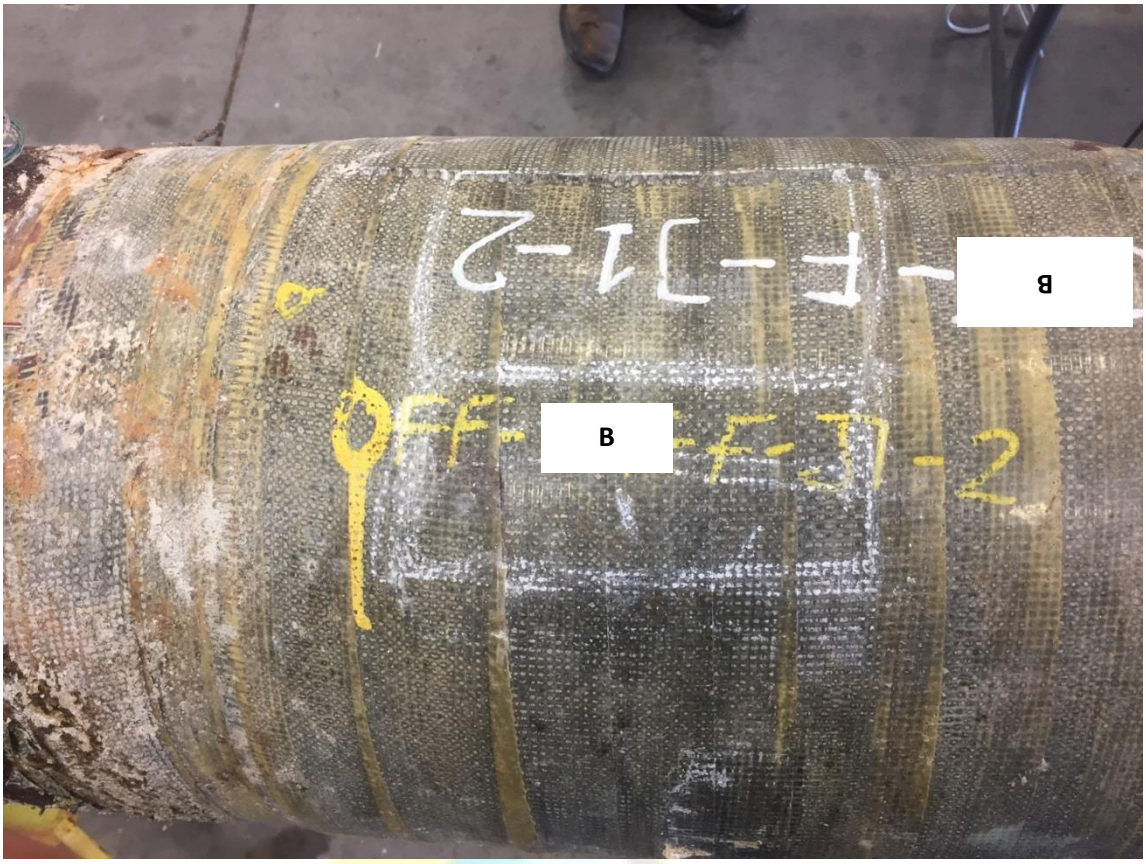
Relevant Indication # 1 (At the 0 marker / Nozzle). 3” from edge of wrap closer to nozzle

- Approximately 8” x 6”
